**Project Silent
ANZAC**

**Preliminary
Analysis of
Imagery Data**

Preliminary Analysis of Imagery Data arising from the 2014 Internal Investigation of HMAS AE2

Dr Roger Neill

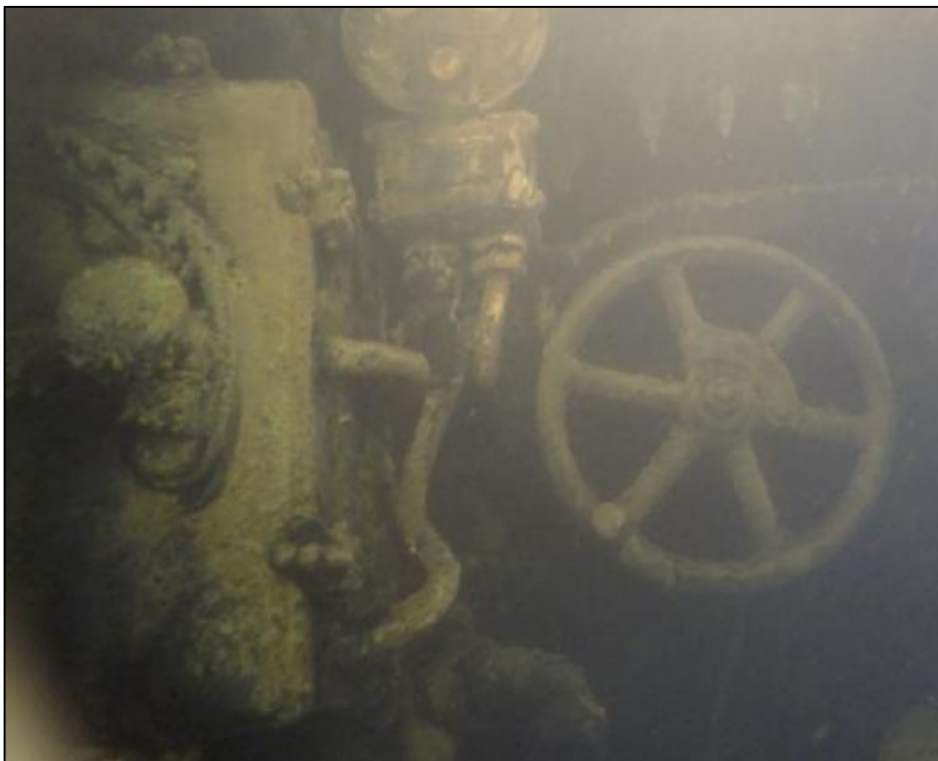
Figure 25 - The First Image Recorded by the DSTO ROV from inside the Control Room

(It shows the starboard ballast pump control slide, a Kingston wheel and a pressure gauge.)

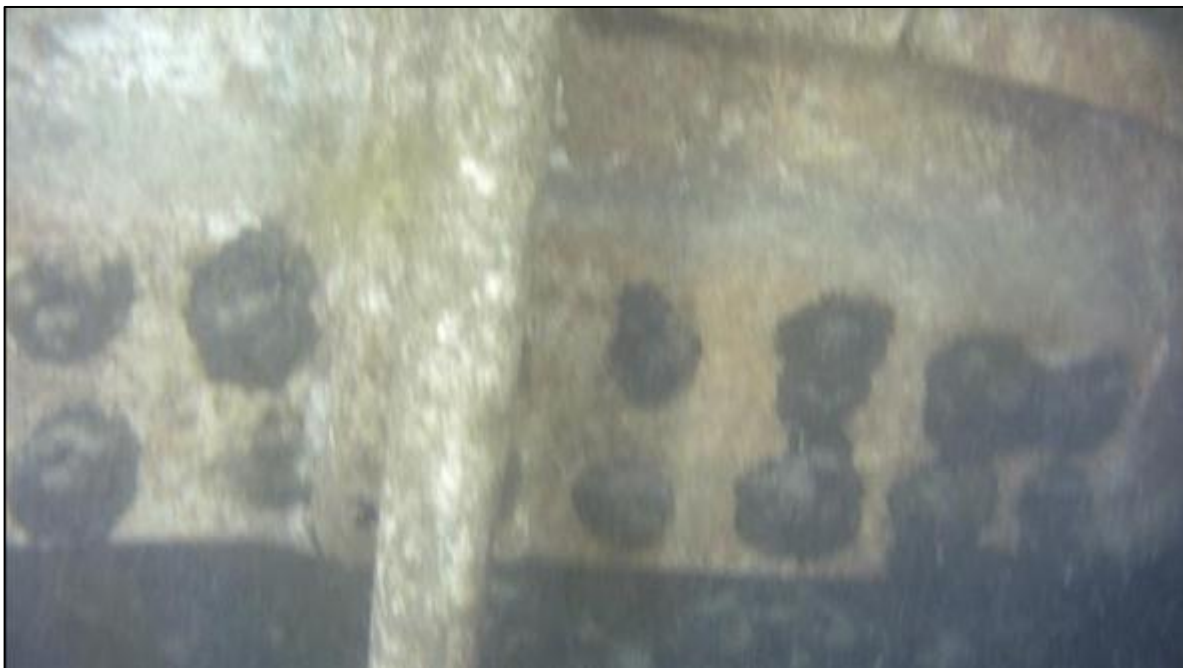
Figure 32 - This Image shows the Twin Lines of Rivets that join the Two Parts of the Conning Tower

It was known that the upper portion of the conning tower was cast out of non-ferrous material and that the lower half was steel. A matter of considerable interest to the science team was to investigate how well the interface between the two parts of the conning tower had survived. As early as 1763 the Royal Navy frigate HMS *Alarm* had been used in an experiment on the use of copper sheeting for antifouling, with the result that iron fasteners were rapidly lost to corrosion (6). Clearly, in the case of AE2, the rivets joining the two parts of the conning tower have been carefully isolated from the brass, as they are still appear to be quite sound.

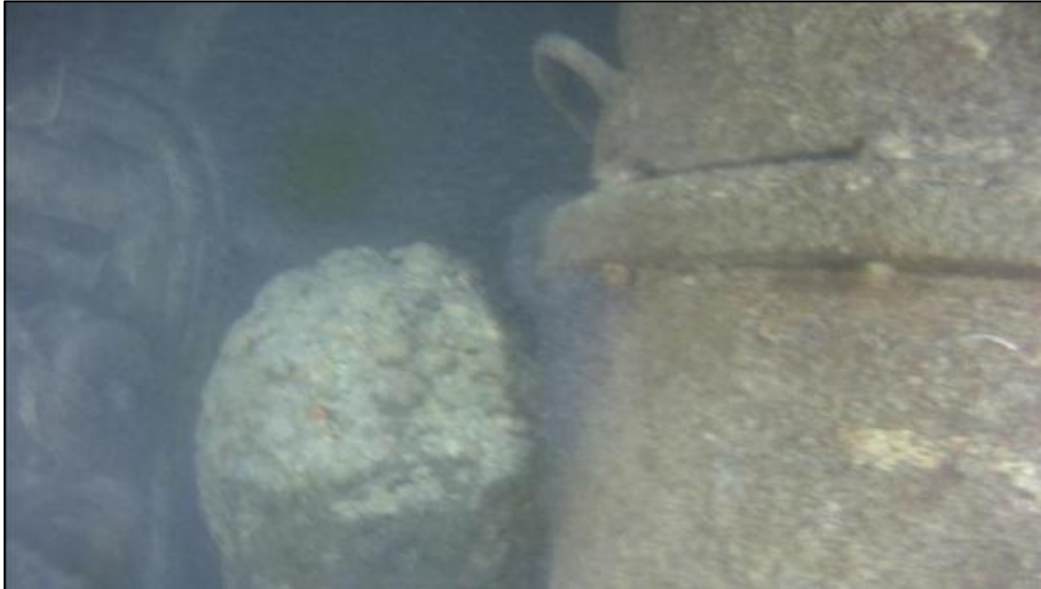
Figure 33 - The Portside Soft Iron Sphere adjacent to the Housing for the Magnetic Compass

The magnetic compass was mounted high up in the conning tower, where it was clear of ferrous metals. This compass is in good condition, it still has the soft iron spheres on either side of it and the light pipe, leading to the lower helmsman's position in the control room, is still in place.

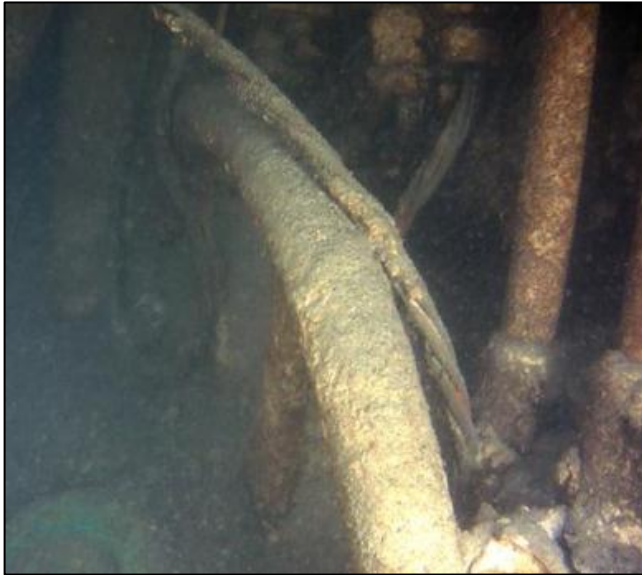
Figure 36 - The Two Parts of the Bridge Steering Wheel are stored in the Conning Tower

(Note the spokes of the wheel. The cable lying on the rim of the wheel is three-core electrical cable, with insulation still relatively intact.)
