**Project Silent
ANZAC**

**Preliminary
Analysis of
Imagery Data**

Preliminary Analysis of Imagery Data arising from the 2014 Internal Investigation of HMAS AE2

Dr Roger Neill

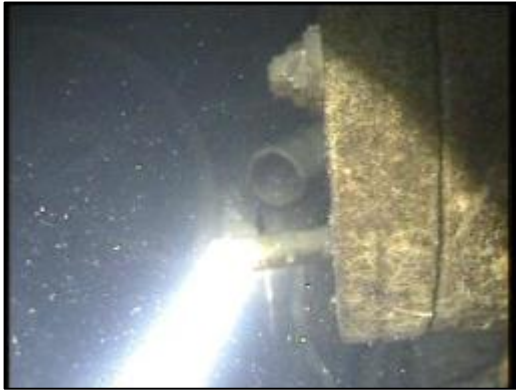
Figure 3 - An Image recorded from the MK 1 Drop Camera used during MAA07, showing the Conning Tower Telegraph at Right.

The experience of MAA07 (3) had been that it was advisable to separate the source of illumination as far as possible from the camera, as co-locating camera and light source causes bad "flaring" due to specular reflection from suspended matter in the water, as can be seen in Figure 3. Hence it was decided to build luminance-controllable, LED lighting modules that would be mounted approximately 450 mm above and below the centreline of the camera. Providing two lighting modules had the twin benefits of:

(Note the flare on the image is a result of having the light source virtually co-located with the camera.)

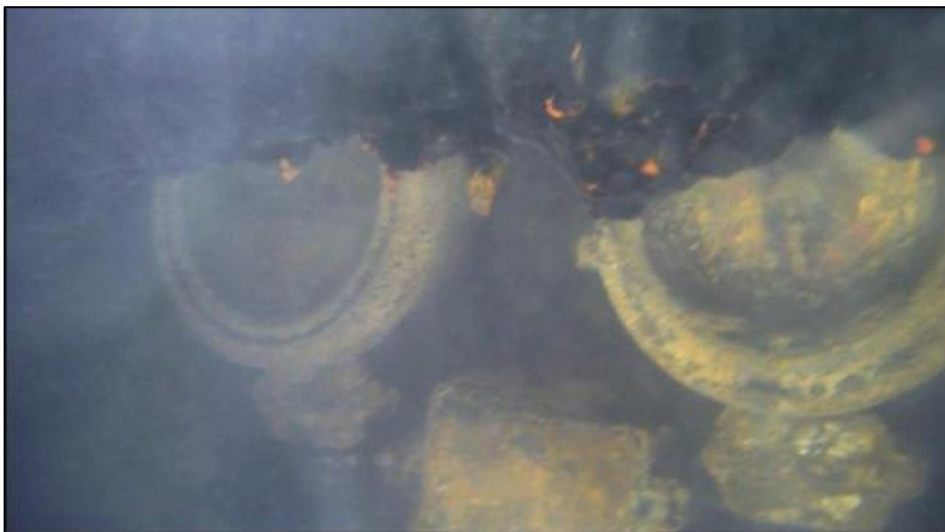
Figure 22 - The first view of Speed and Depth Gauges as the Drop Cam is lowered into the Control Room

On the second attempt the system was successfully installed into the boat, with the Sonde being lowered to the level of the battery tank. The lighting modules proved very effective in providing uniform, soft light for the interior; hence excellent video imagery was able to be recorded. Figure 22 shows the first view of the control room's starboard side as the camera cleared one of the suspended, overhead trunks. The "smoky" appearance of the image is not an artefact. This is a realistic representation of what the water is like near the top of the control room. On this occasion the diver exhausted his time on the bottom so the system was left inside the submarine overnight.

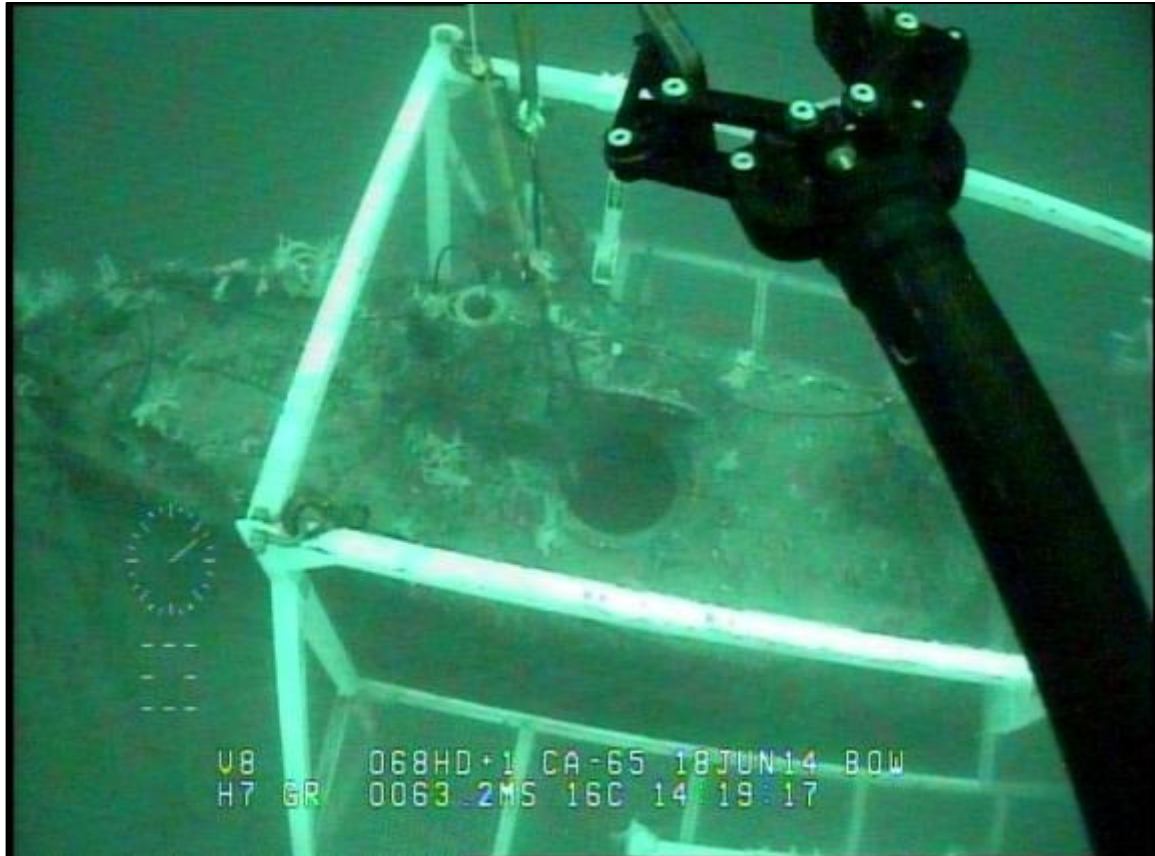
Figure 23 - Showing the Final Orientation of the Opened Upper Hatch

Regardless of whether the Pole Cam was to be deployed or not, the hatch had to be opened to allow insertion of the ROV. The divers configured a long-travel, mechanical screw jack so that its baseplate could rest on the hatch "coaming"⁷ and a modified runner inserted under the hatch lid. This proved very successful in opening the hatch, but as the hatch opened the top of the jack had to shift over to port to follow the rotation of the hatch cover. The result was that, eventually the jack slipped under the copper jumping wire, which links the two periscope standards, and jammed. At this point the hatch was judged to be opened to an angle of approximately 75 degrees, as shown in Figure 23. Considerable time was lost in releasing the jack from the jumping wire and geometric modelling showed there should be sufficient clearance to allow the vLBV to be installed into the submarine, so the hatch was left at that orientation. From a material disturbance point of view, the impact of the hatch opening evolution was that a reasonable amount of concretion was removed from the top of the conning tower in the vicinity of the hatch (varying between about 50-100 mm), one hatch clip had to be cut and the hatch was rotated through approximately 65 degrees.

⁷ The hatch opening was not surrounded by a traditional, raised coaming. It was in fact effectively a recessed opening cast into the top of the conning tower.

From both a maritime archaeological perspective and for the sake of the security of the wreck, it was important to restore the upper hatch opening to something approximating the original 10 cm gap. Given that the concretion, which had been effectively securing the hatch prior to the mission, had been dislodged it was not an option to simply close the hatch again. A fiberglass replacement hatch cover had been manufactured prior to the expedition. This cover, shown below, had slots cut into it to simulate the original opening. It was placed over the hatch opening and secured to a "strongback" (the grey object lying on top of the cover), that engaged with the underside of the hatch coaming.

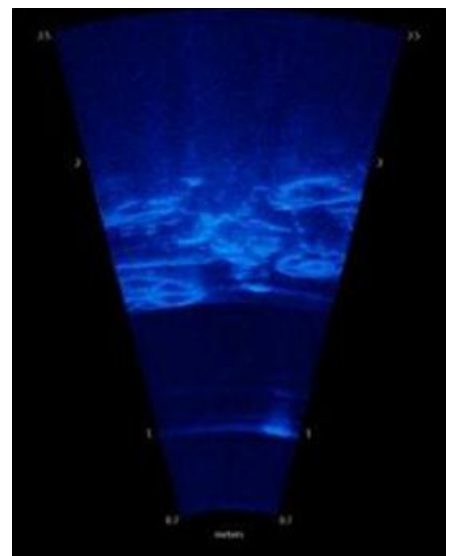
Figure 28 - Video & Sonar Images at the same Position

Figure 28 shows imagery, recorded separately from HD video and the ARIS sonar. The images are looking to starboard, and they both show two of the Kingston valve actuation wheels, plus some of the other ballast control infrastructure. While it may appear to be the case, these images were not recorded simultaneously. The reader is reminded that the sonar is actually a two-dimensional ranging system, not a three-dimensional imaging system. What is actually shown in the sonar images are two-dimensional slices, taken along the direction of the sonar's field of view. In this case, by chance, at one point the system tilted somewhat, so that the sonar was looking slightly upwards, hence the wheels look like wheels. The sonar image which was, in fact, recorded simultaneously with the video image is included as Figure 29. That sonogram takes the form of a cross-sectional view through the Kingston wheels, including presenting a cross-section of the turning handle attached to one of the wheels. Also evident is some of the piping that led to pressure gauges and tapping points. The fidelity of the sonar imagery is sufficient to show that it can be used to facilitate dimensional scaling.

A significant amount of the HD vision and ARIS sonar data were obtained from the SeaBotix vLBV in the conning tower. These data highlighted one of the limitations of the sonar system. For much of the time the distance between the sonar and the sides of the conning tower was closer than the 0.7 metre minimum range which the sonar could resolve, resulting in no displayed signal on the screen. Also the cramped confines and the shape of the conning tower resulted in multiple "bounces" of the sonar signal being received, distorting the displayed return signals. This in no way negates the potential value of utilising sonar data - it simply highlights the fact that acoustic systems have characteristics which must be accommodated, just as video imagery does. As a case in point, the video imagery in Figure 28 is degraded by turbidity of the water, whereas the sonar image is quite unaffected.

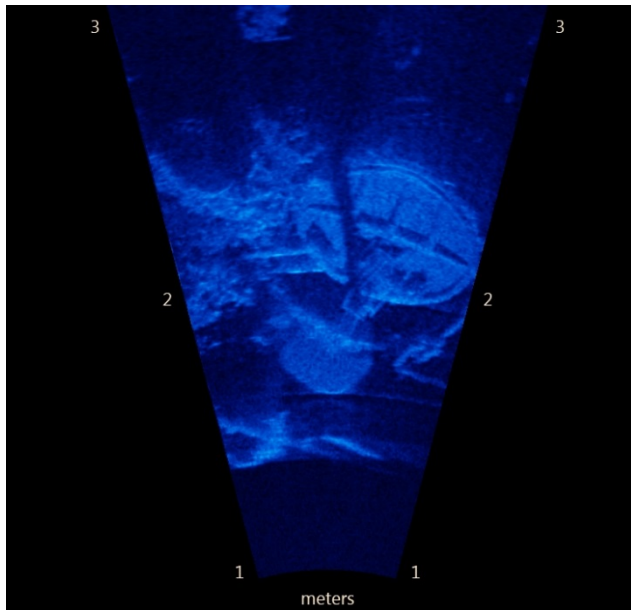
Figure 30 - ARIS Sonar Image of AE2 Top Hatch

Figure 30 is another ARIS sonar image. This was recorded from outside the ROV, looking into the gap between the conning tower and the upper hatch while opening operations were being undertaken. The reader is reminded this is a ranging device – while it appears that the image is looking down on the

hatch cover, in fact it shows the reinforcing ribs on the underside of the cover. Also visible is the base plate of the jack and part of the jack's winding mechanism.

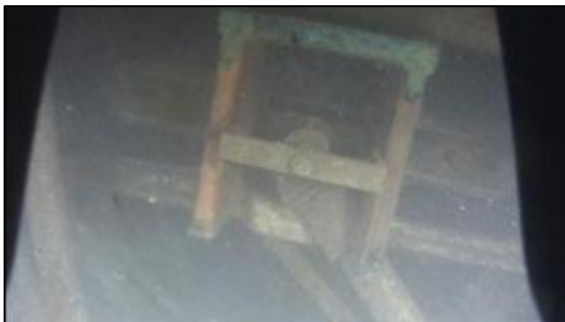
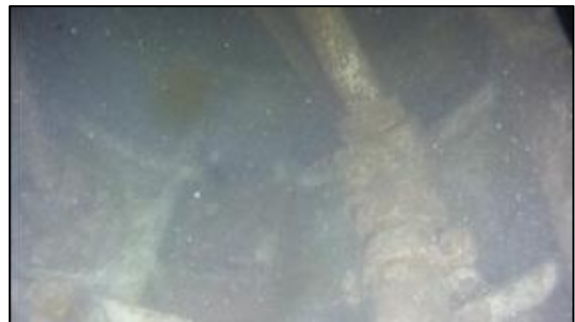
Figure 34 - Showing the Light Pipe that led down to the Control Room

The magnetic compass was mounted high up in the conning tower, where it was clear of ferrous metals. This compass is in good condition, it still has the soft iron spheres on either side of it and the light pipe, leading to the lower helmsman's position in the control room, is still in place.

(Image at **left** is looking upwards towards the compass and image at **right** shows the "elbow" in the pipe mounted at the starboard side of the conning tower.)

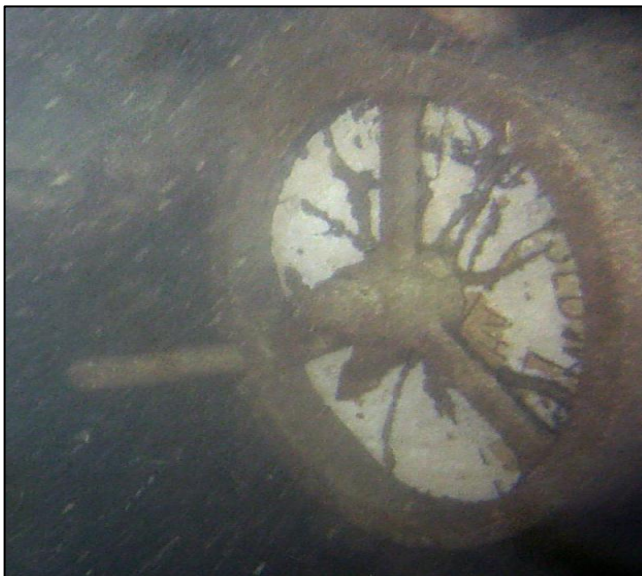
Figure 37 - Starboard Engine Telegraph

The following images give some idea of the large number of items of interest identified in the conning tower. The telegraph is identified in the plans (Drawing 11) as being an indicator for the starboard engine only. This is consistent with what can be seen on the instrument.

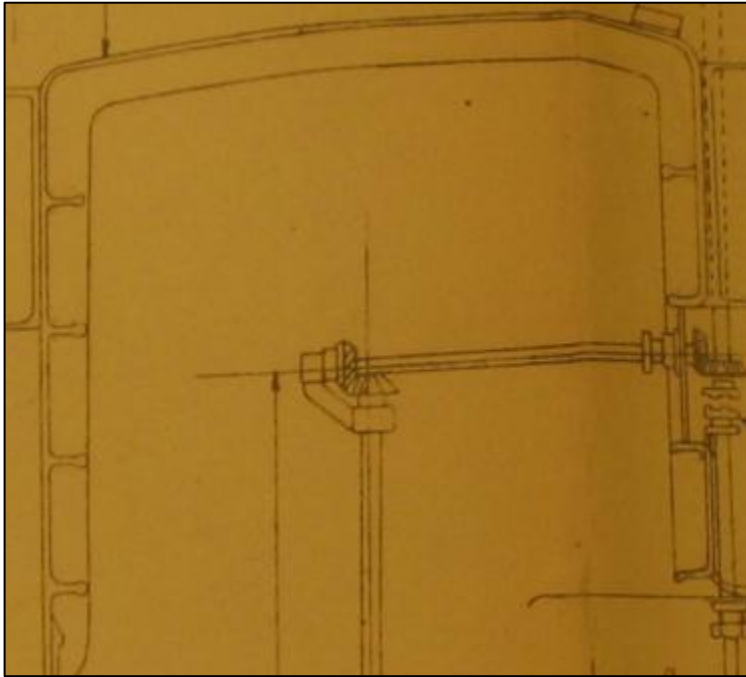
Figure 38 - The Right Angle Drive for the Steering System – Mounted off the Port Side Wall of the Conning Tower

The following example highlights the manner in which MAA14 has expanded upon existing knowledge of AE2's hardware. The only plan which the team has been able to locate, indicating the manner in which the steering actuation was transferred from the two upper steering positions down to the control room, shows a very simple right-angle drive system with exposed gears.

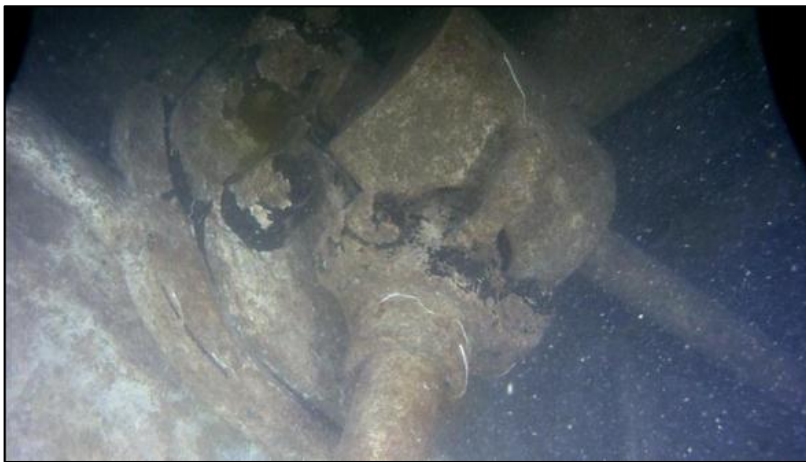
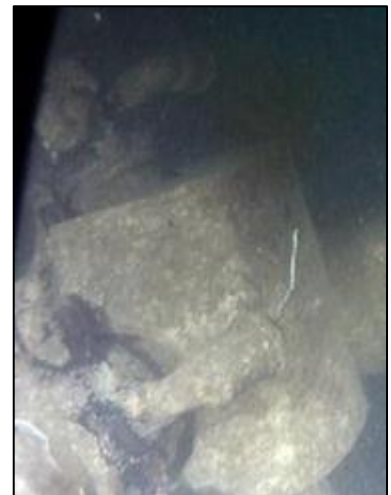
Figure 39 - Two Views of a Right-Angle Drive in the Steering System

The reality was that the gearbox was totally enclosed, but it carried external grease pots which could be filled with grease and then progressively screwed in, enabling the unit to be charged with grease without the need to use a separate grease gun.

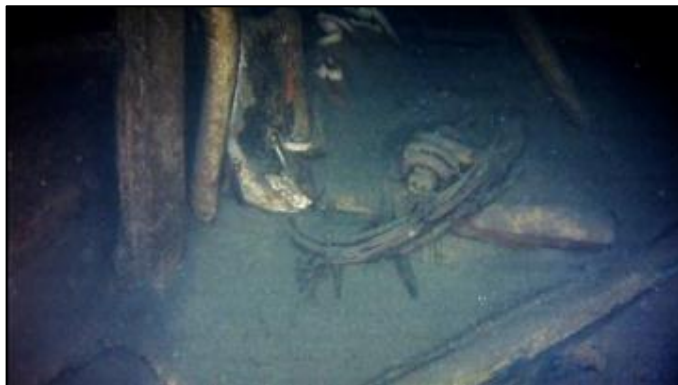
Figure 41 - A Hinged Bracket with Coil of Wire lying on top of it

A number of items were found inside the conning tower which could potentially have been used to make such a temporary radio antenna. A steel plate was found on the floor, with a hinged bracket attached to it. Lying on top of that was a coil of wire and there were at least two poles stowed in the space. While it is not claimed that these were the components of a jury-rigged radio transmission system, further study into their potential uses is certainly warranted.

(There were also at least two poles in the conning tower which were not part of its permanent equipment)
